# **As-Built Geotechnical Report For Emergency Stabilization**

**5700 Block Soledad Mountain Road, La Jolla, California**

**SUBJECT: As-Built Geotechnical Report for Slope Stabilization**

**RE: 5700 Block Soledad Mountain Road and Desert View Drive Alley  
La Jolla, California**

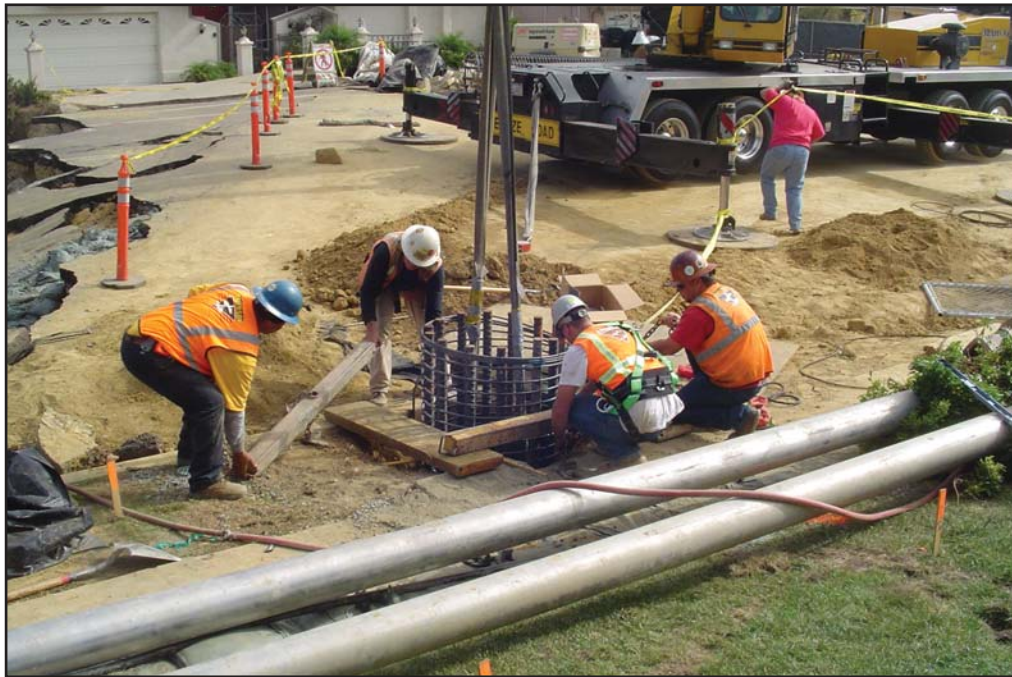
INSTALLATION OF TEMPORARY SHORING ALONG WEST SIDE OF SOLEDAD MOUNTAIN ROAD SOUTH OF LANDSLIDE MASS

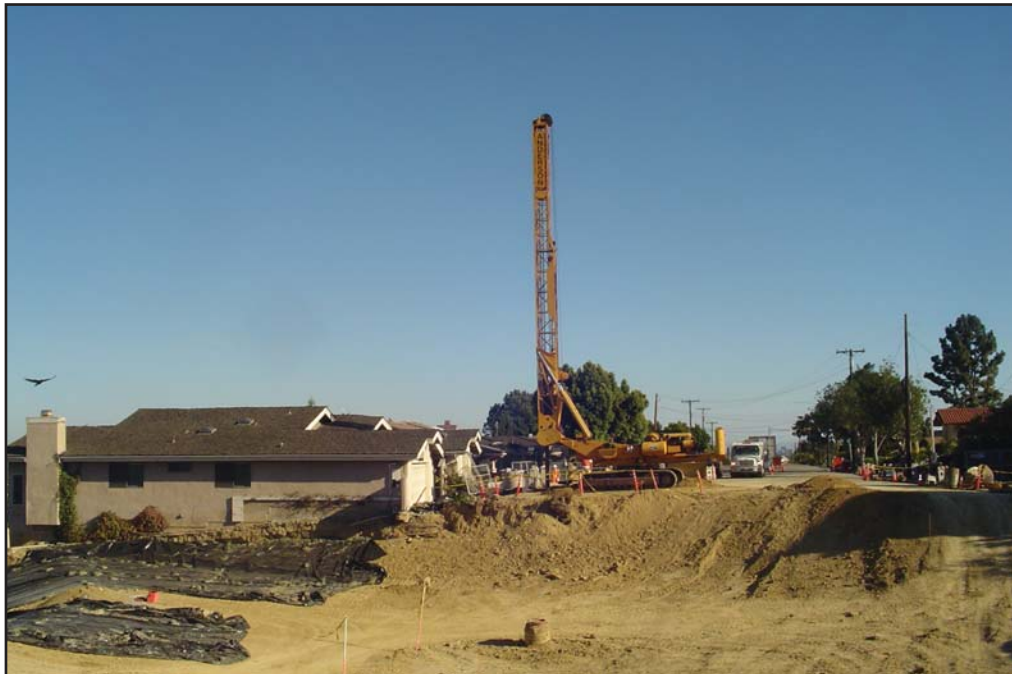
DRILLING OF EAST SIDE SHORING SOUTH OF LANDSLIDE MASS

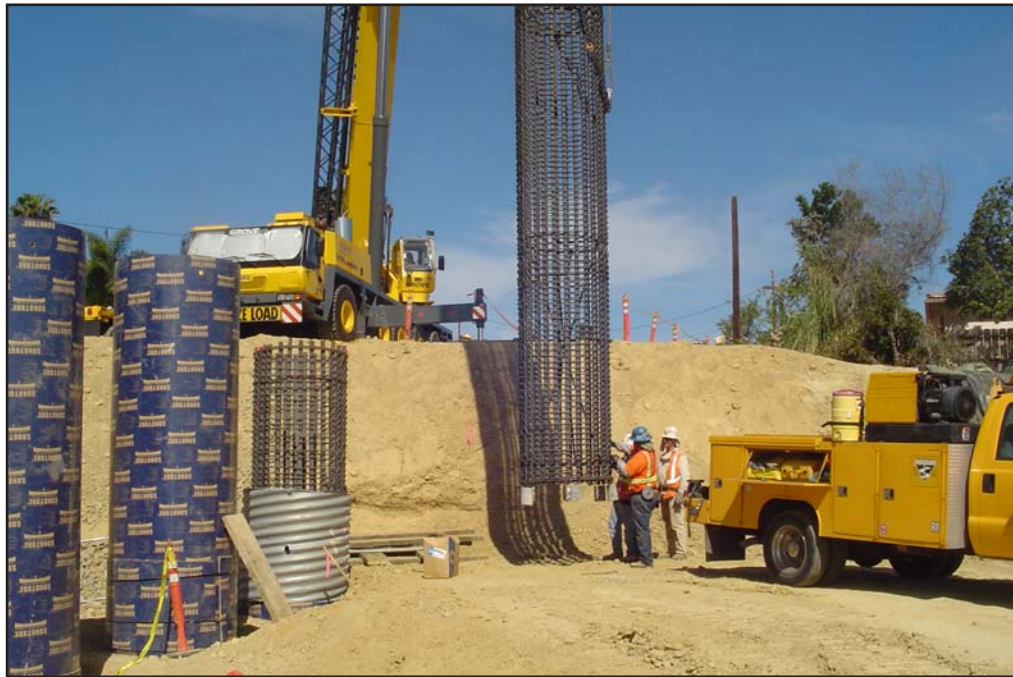
INSTALLATION OF EAST SIDE SHORING REINFORCEMENT CAGE ON NORTH SIDE OF LANDSLIDE MASS

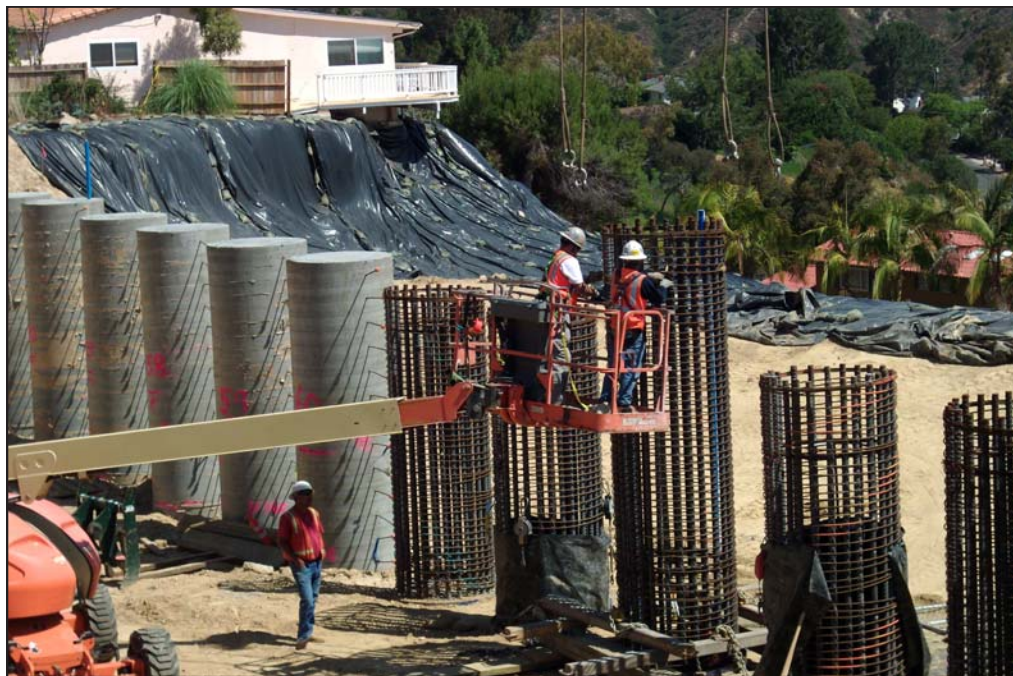
INSTALLATION OF EAST SIDE SHORING REINFORCEMENT CAGE ON SOUTH SIDE OF LANDSLIDE MASS

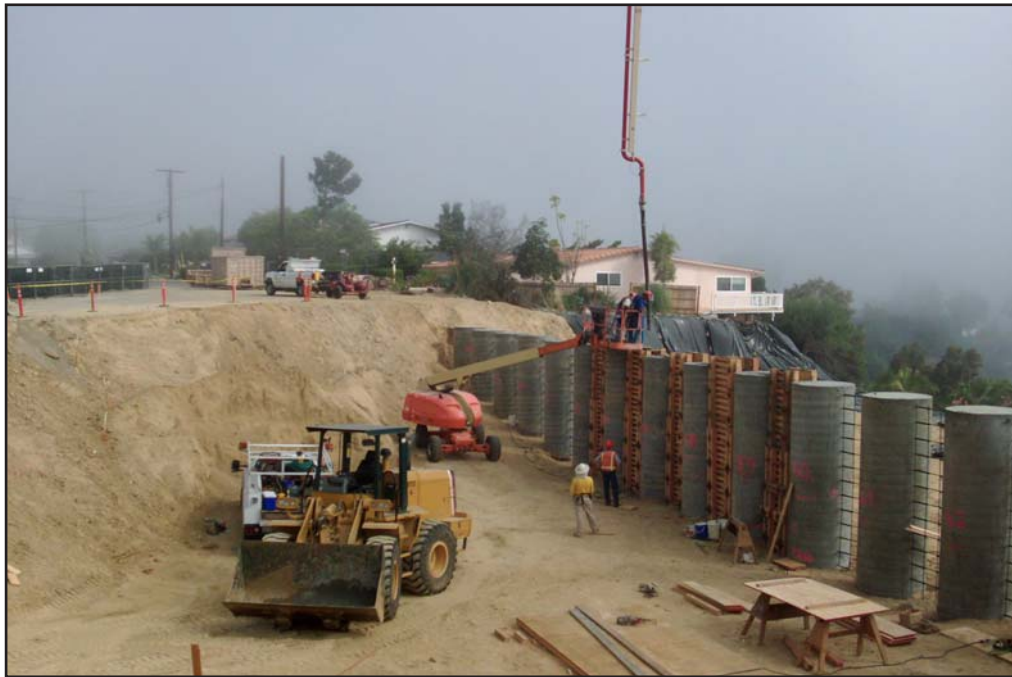
PLACEMENT OF CONCRETE FOR PANEL WALLS BETWEEN EAST SIDE SHORING

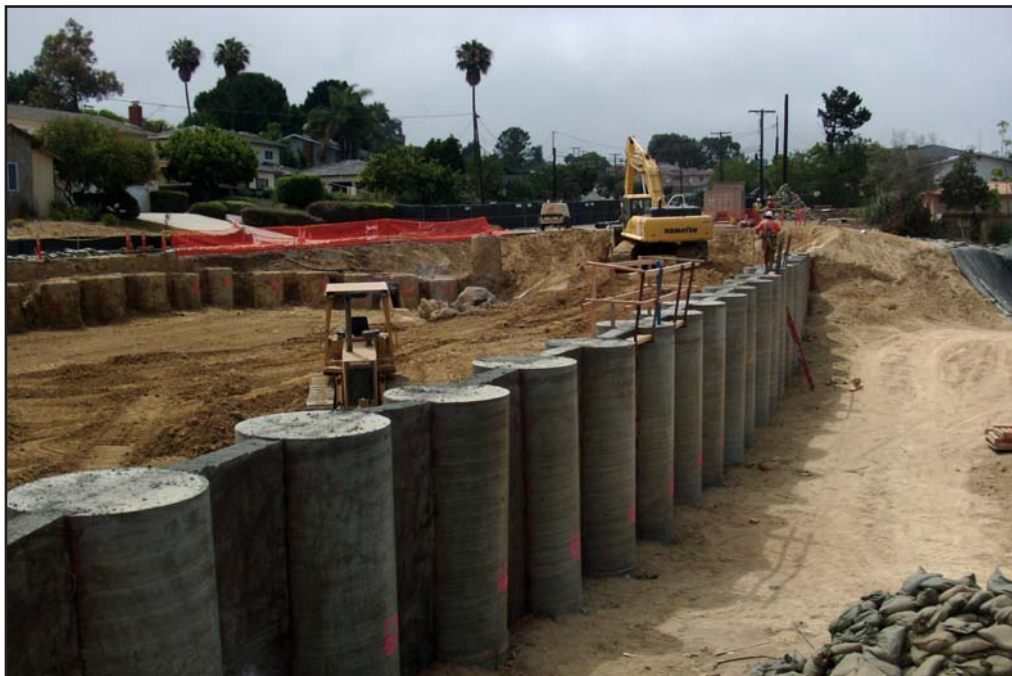
EXCAVATION OF SLOT 1 WITH COMPLETED PANEL WALL IN FOREGROUND

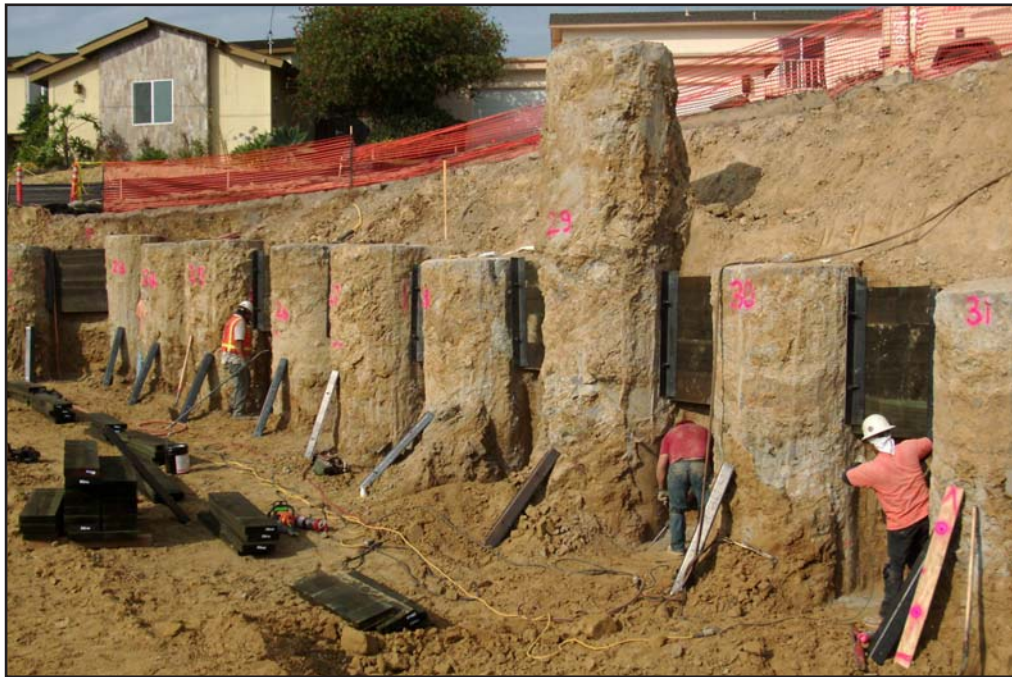
INSTALLATION OF PRESSURE TREATED LAGGING BETWEEN TEMPORARY SHORING IN SLOT 1

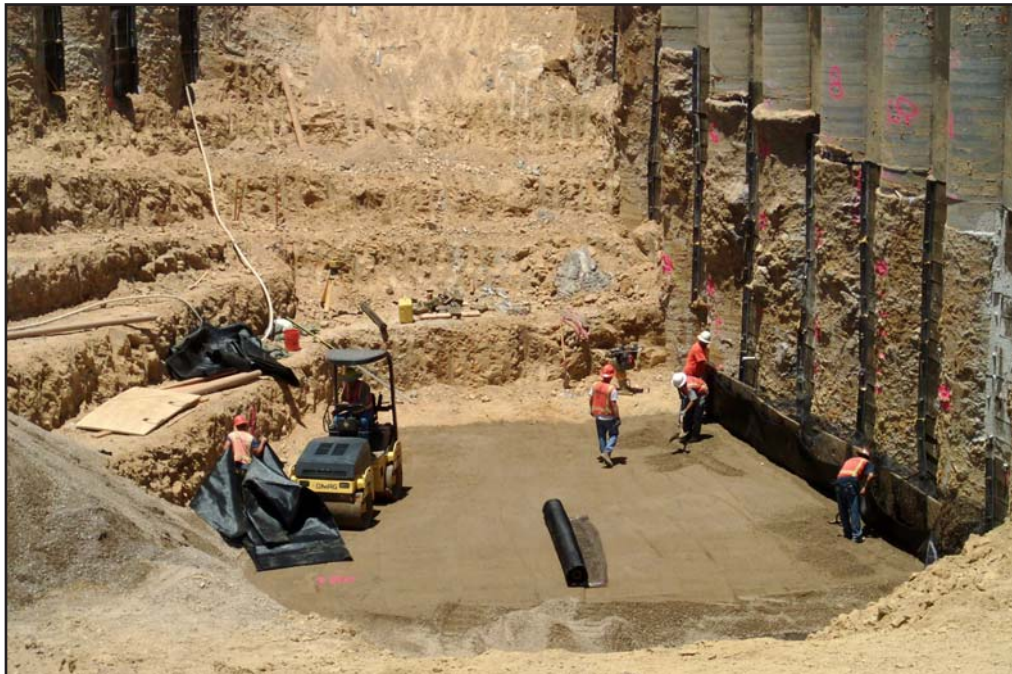
FILL PLACEMENT IN THE BOTTOM OF SLOT 1

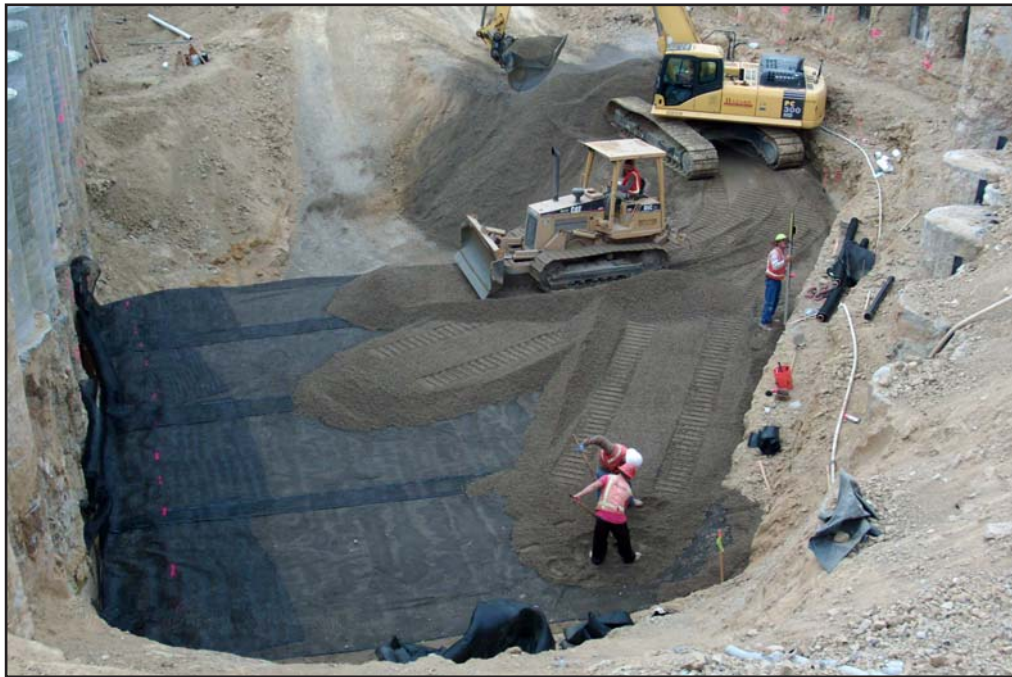
FILL PLACEMENT ABOVE MIRAGRID 10XT IN SLOT 1

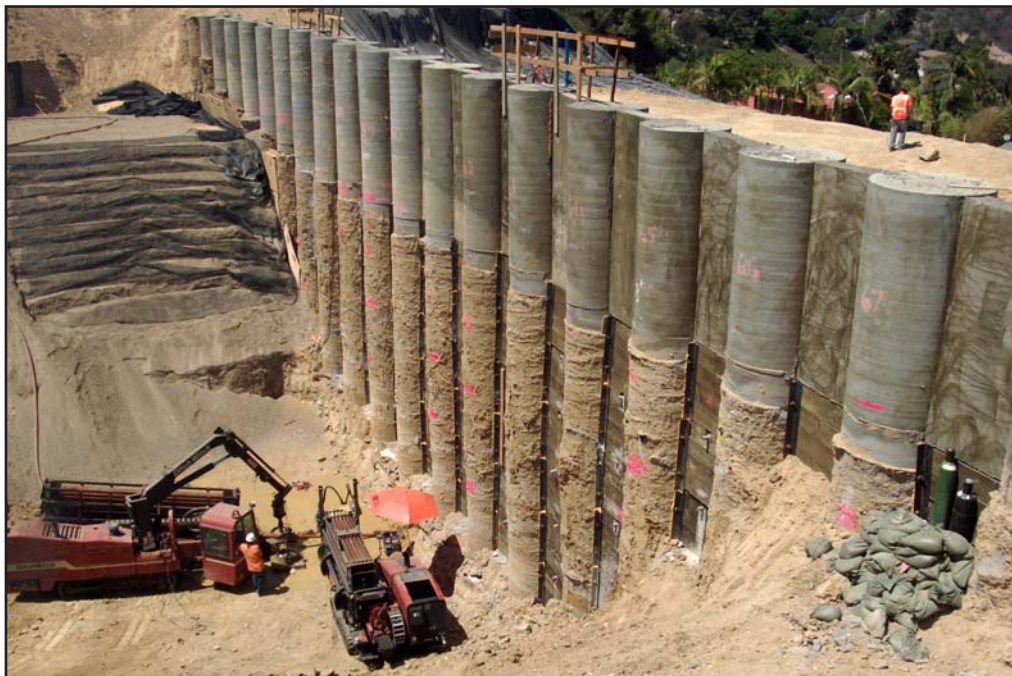
DRILLING OF KEYWAY SUBDRAIN OUTLET AT THE BOTTOM OF SLOT 2

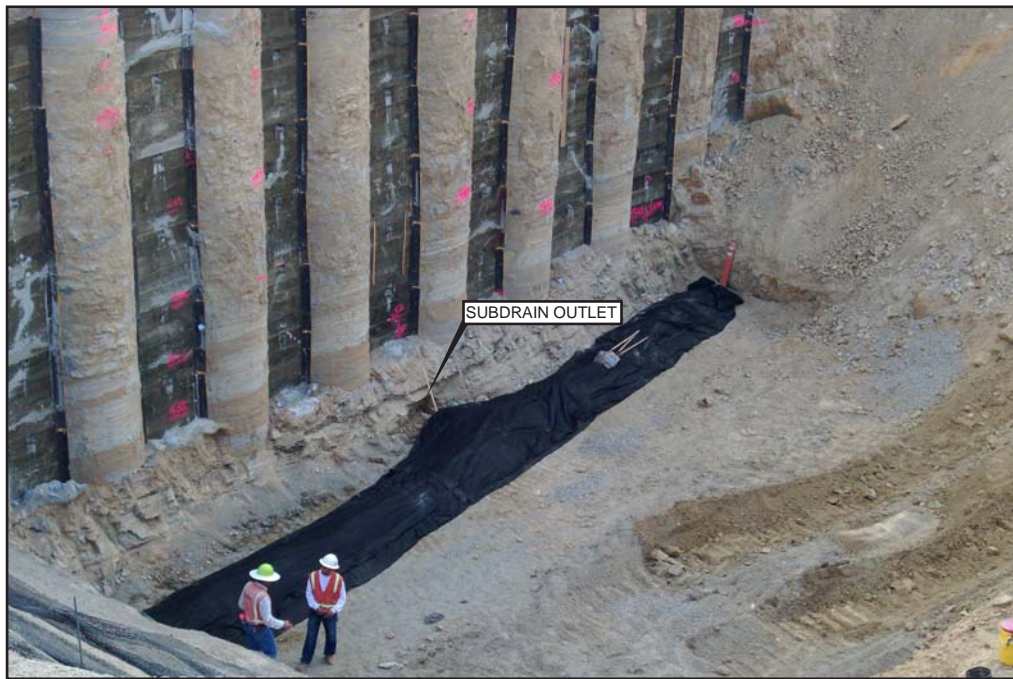
COMPLETED SUBDRAIN IN SLOT 2 KEYWAY

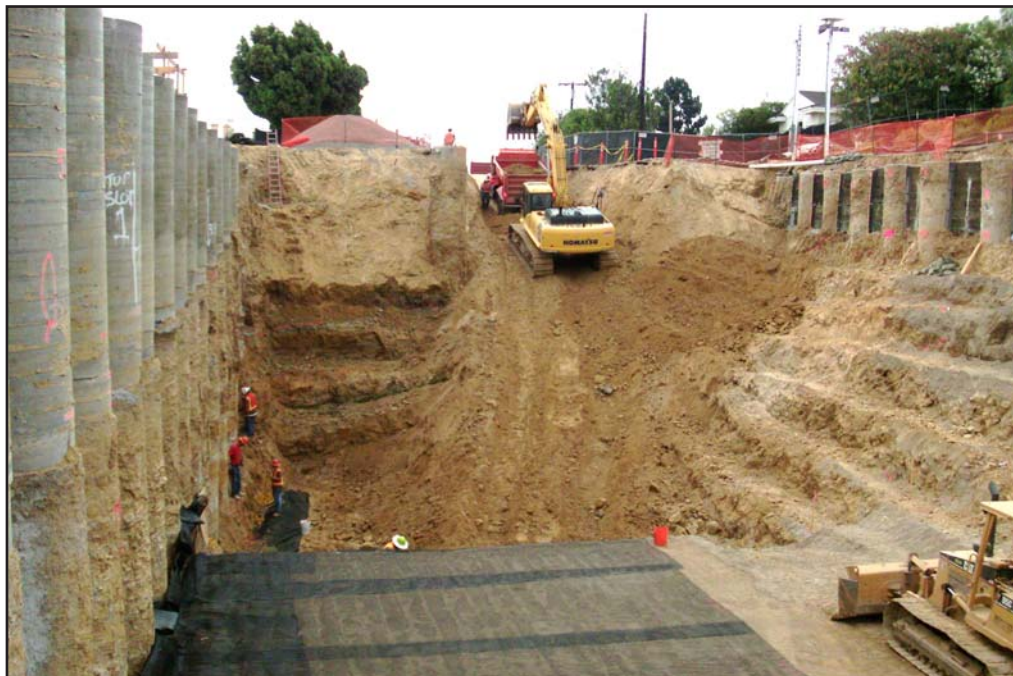
GEOGRID PLACEMENT IN SLOT 2. EXCAVATION OF SLOT 3.

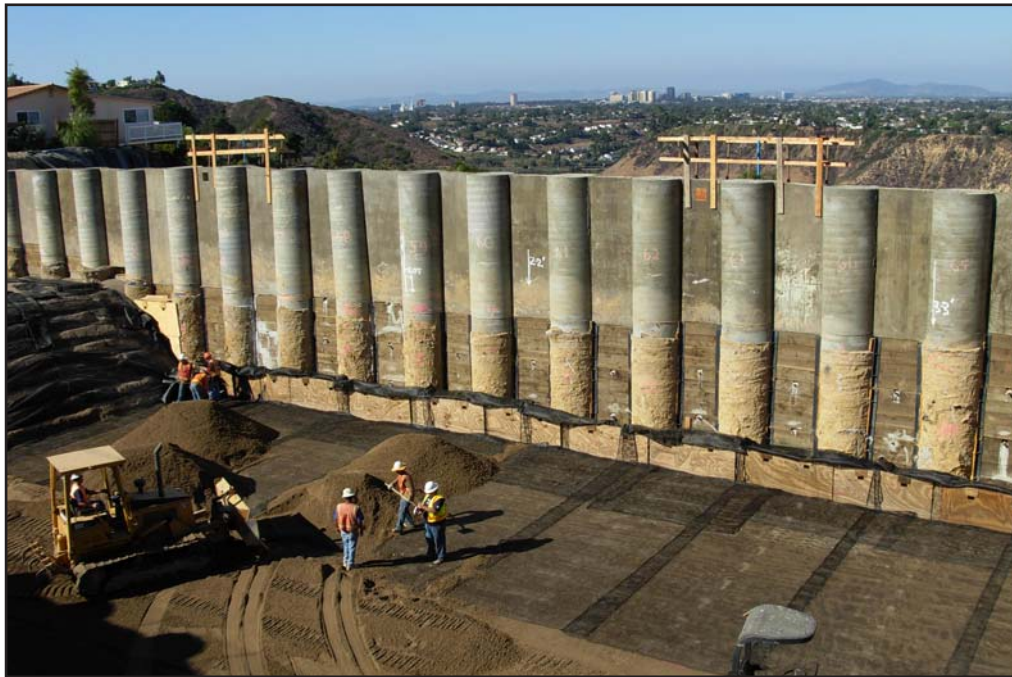
GEOGRID (MIRAGRID 10XT) AND FILL PLACEMENT IN SLOTS 2 AND 3

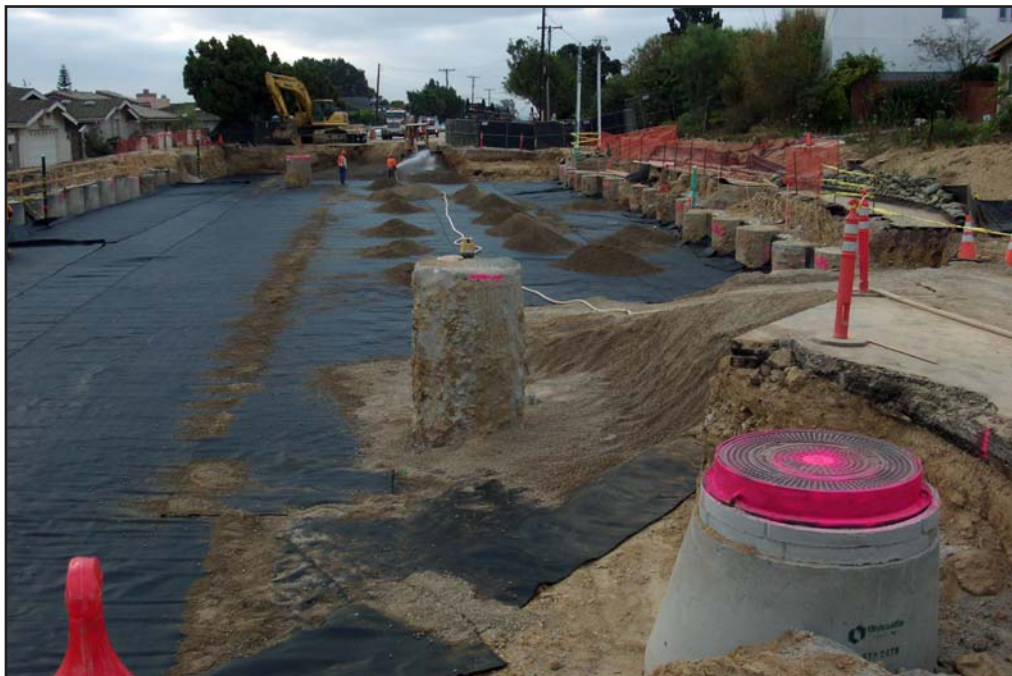
PLACEMENT OF MIRAFI HP570 AT ELEVATION 469' (APPROXIMATE)

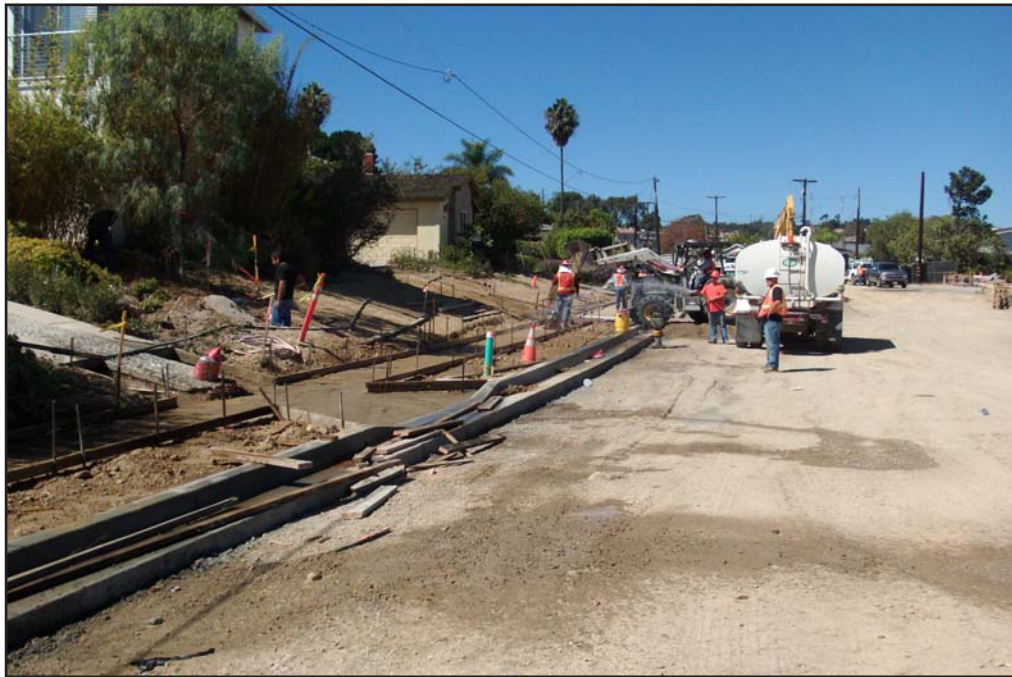
SUBGRADE PREPARATION IN SOLEDAD MOUNTAIN ROAD AND CURB AND GUTTER CONSTRUCTION

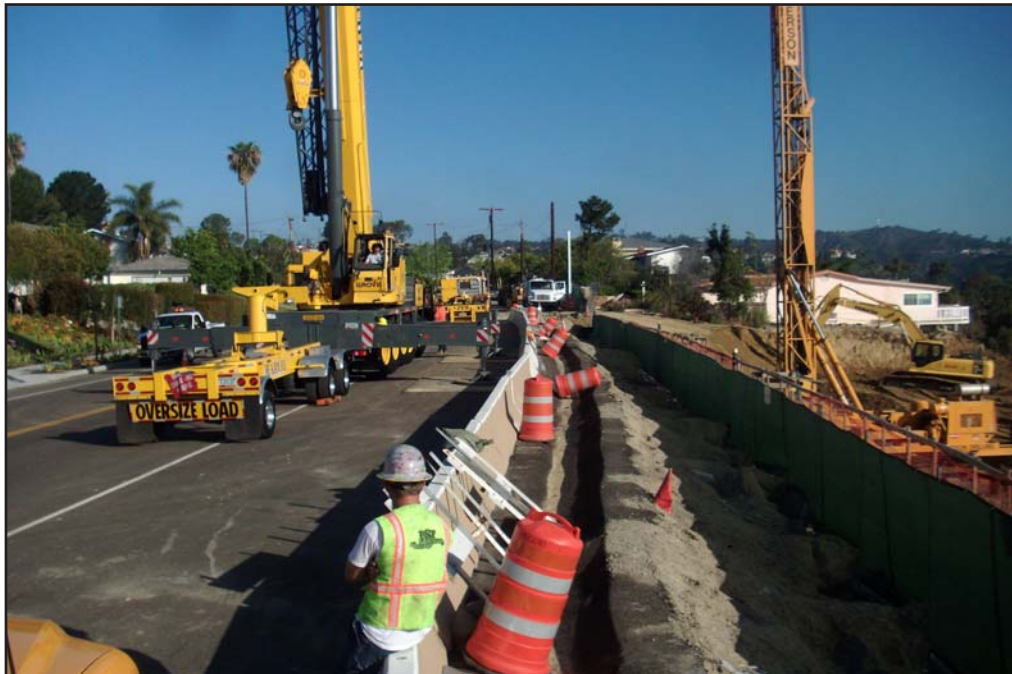
K-RAIL AND TEMPORARY FALL SLOPE ALONG EAST EDGE OF SOLEDAD MOUNTAIN ROAD
